Subj: COMMAND INVESTIGATION INTO THE EVENTS SURROUNDING THE CRASH OF A CARGO
RESUPPLY UNMANNED AERIAL SYSTEM, BUREAU NUMBER A-11497, ON OR ABOUT 5
JUNE 2013

1. On 5 June 2013, at approximately 2017, a Cargo Resupply Unmanned Aerial System (CRUAS), impacted the ground at the Helicopter Landing Zone (HLZ) at Forward Operating Base (FOB) (b)(7) during a resupply mission.

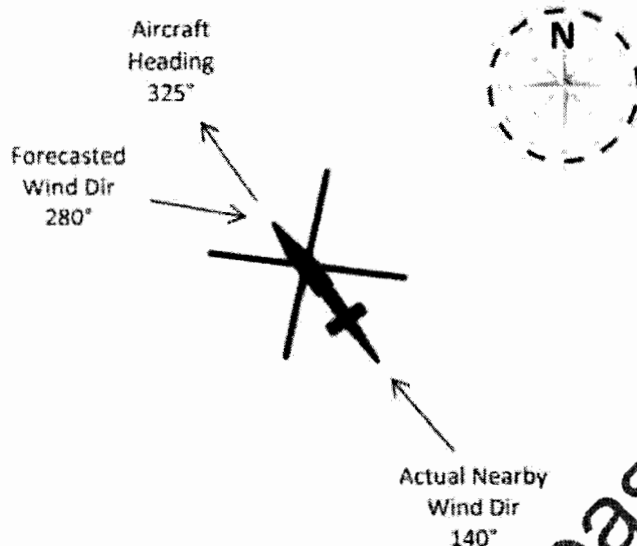
(4) Influence of Wind. The crew used the planned weather to determine that the aircraft was in a headwind and the weathervane technique to allow the aircraft to reorient if this was not accurate, enclosure (2). The following figure depicts the aircraft heading, planned wind direction, and the observed wind at FOB (b)(7)F. The actual wind was coming from a direction behind the aircraft based on weather observations near FOB (b)(7)F and observing the wind effect on smoke in the video of the mishap, reference (1).
